LANGAN ENGINEERING ASSOCIATES INC CLIFTON NJ
NATIONAL DAM SAFETY PROGRAM. SWANNANOA LAKE DAM
FEB 79 D LEARY

17. DISTRIBUTION STATEMENT 6 National Dam Safety Program. Swannanoa Lake Dam Number 2 (NJ 00310). Passaic River Basin, Rockaway River Tributary, Morris County, New Jersey. Phase I Inspection Report.	15a. DECLASSIFICATION/DOWNGRADING SCHEDULE

OVERVIEW
SWANNANOA LAKE DAM #2
1 DECEMBER 1978

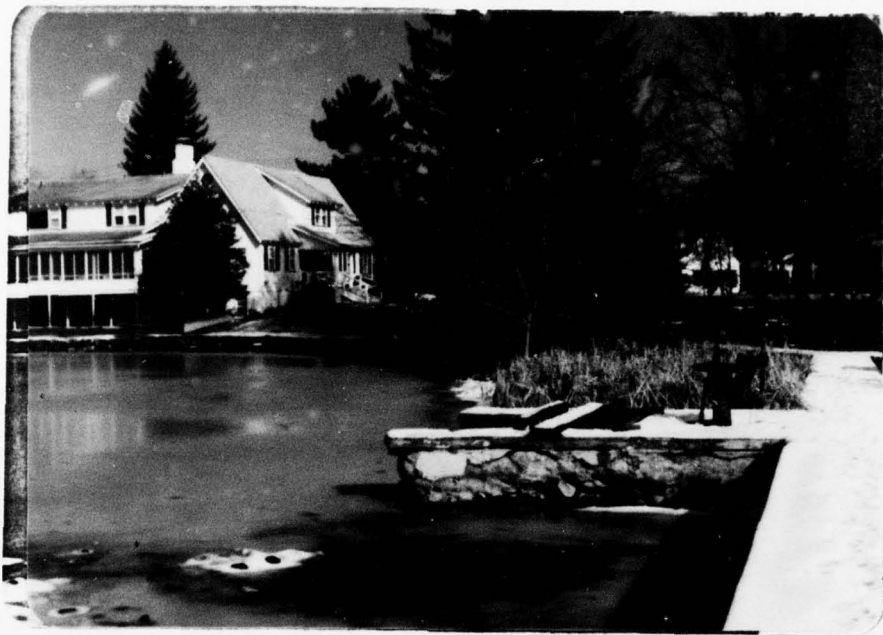
Discharge gate structure .

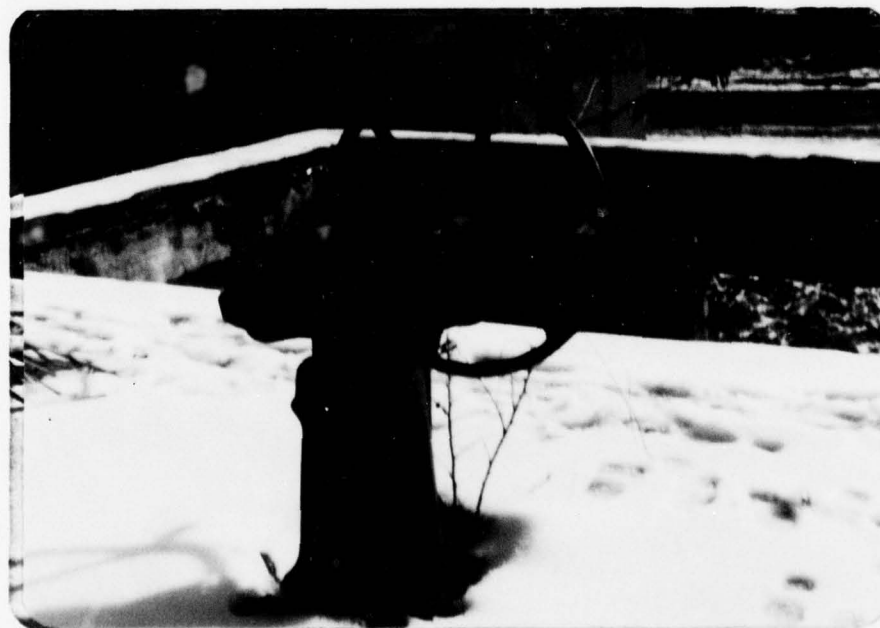
Operator to 4-ft-dia lift gate.

7. Repair and make permanently functional the operator and gate for the 3.5-ft-dia lift gate so that the drop-box spillway can function properly. This should be done very soon.

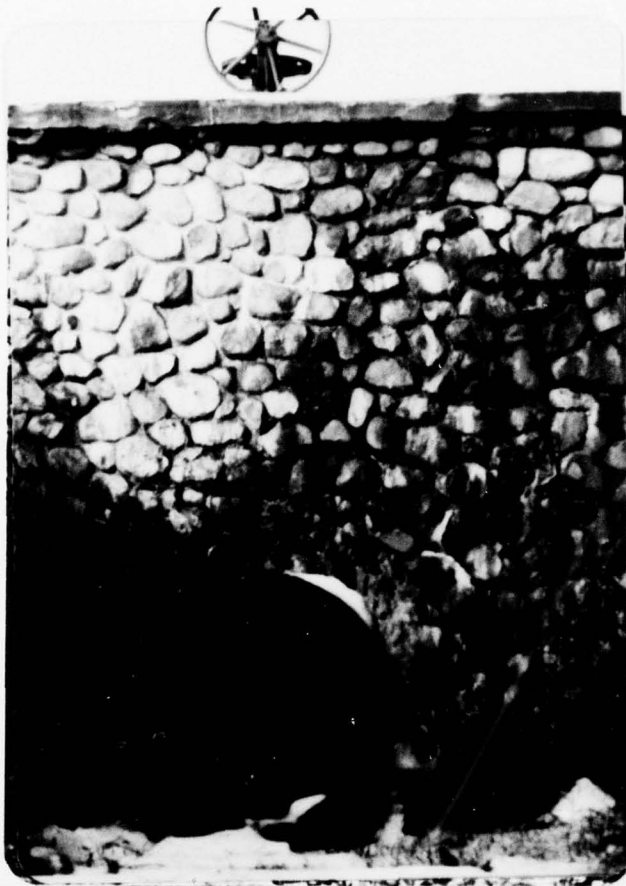
42-in-dia steel pipe leading
from 8-ft drop inlet spillway.

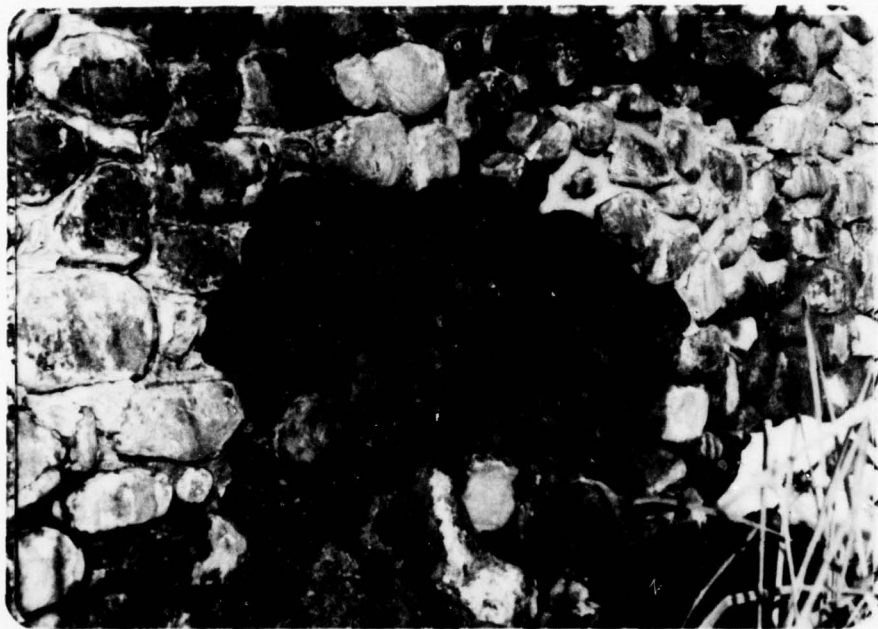
i. CONDITION OF DAM RESULTING IN UNSAFE ASSESSMENT
Seepage through masonry caused bulging of downstream stone wall facings at four locations. One bulge has broken open exposing deteriorated rubble concrete interior.

Bulge collapse and loss of interior
portion of downstream face of dam.

- 1) Drawdown lake three (3) feet within next 30 days.
- 2) Rebuild bulged and collapsed section of rubble masonry facing wall allowing for numerous small weep holes in mortared joints.
- 3) Utilize a qualified professional consultant to inspect the wall weekly and furnish the State a written report of the inspection.
- 4) Prepare an emergency warning and evacuation plan immediately, in event the condition worsens.

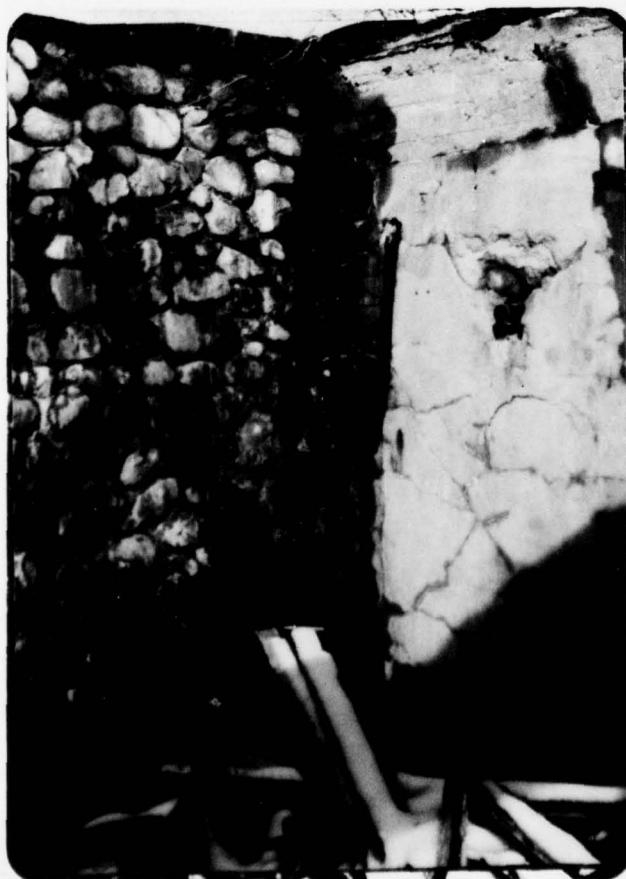
Seepage at downstream face
of dam in abandoned
generator house.

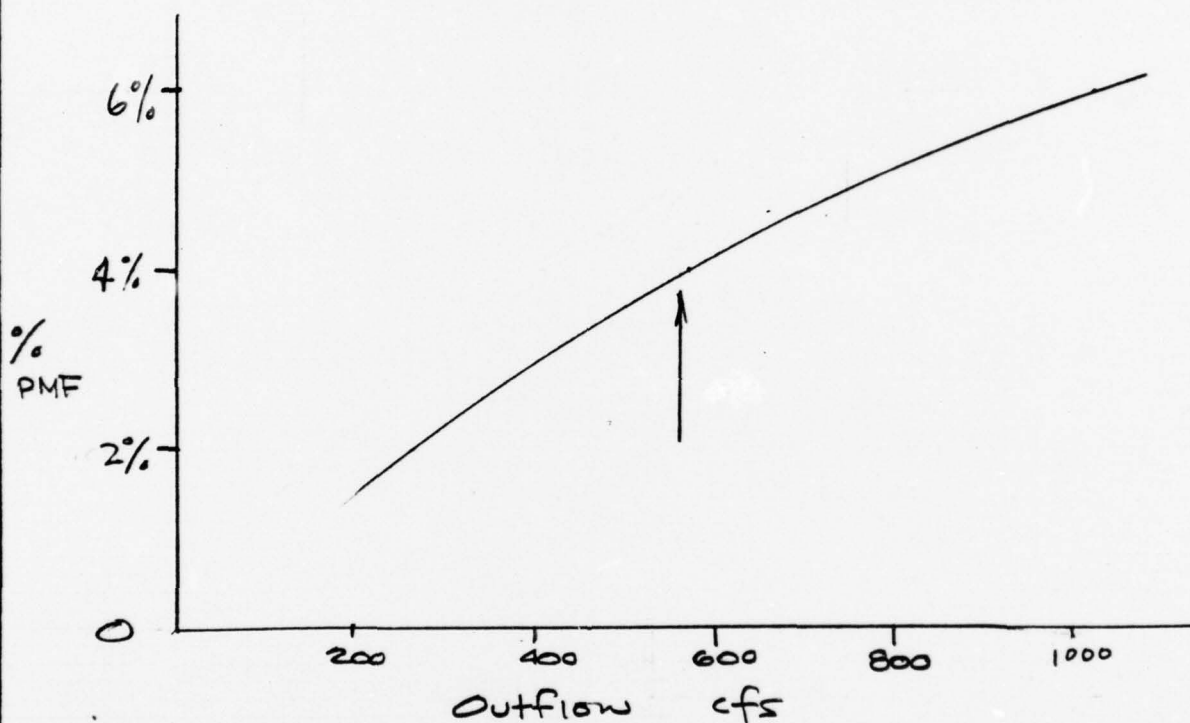
OVERTOPPING POTENTIAL

3. Dam overtops at approx el 773 with $Q = 560$ cfs
 \therefore dam can pass approx 3.9% the PMF
